USAAEFA PROJECT NO. 79-19

**ARTIFICIAL AND NATURAL ICING TESTS  
PRODUCTION UH-60A HELICOPTER**

**FINAL REPORT**

**JUNE 1980**

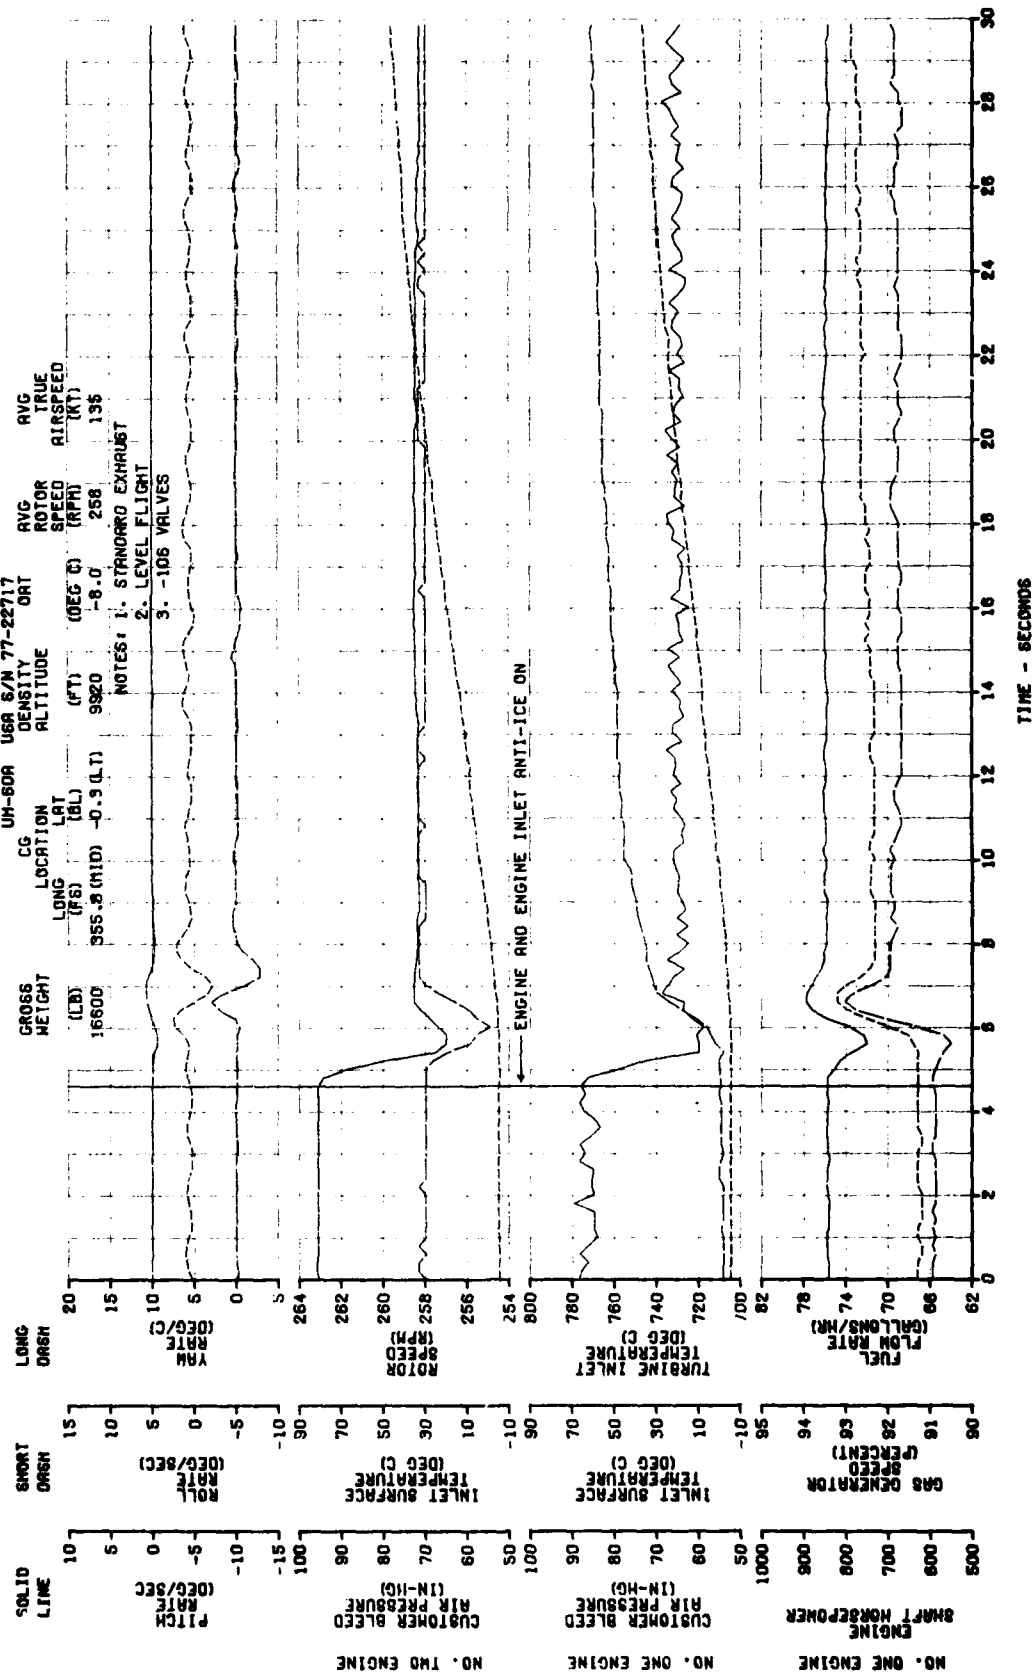
FIGURE 29  
ENGINE AND ENGINE INLET ANTI-ICE ACTUATION

51. The actuation characteristics of the anti-ice/bleed air systems were evaluated throughout these tests. Time histories of turning the engine and engine inlet anti-ice systems ON and OFF for both the -106 and -107 engine inlet valve configurations are presented in figures 29 through 32, appendix F. Both valves exhibited similar characteristics in that approximate  $\pm 2.5$  deg/sec yaw rate oscillation developed which completely damped in approximately 1.5 cycles. The yaw oscillations were most noticeable to the pilot although approximately equal roll rates were recorded. The yaw and roll excursions observed were initially disconcerting in that the accompanying changes in engine/rotor noise and attitude changes were similar to some engine malfunctions. Unless all crew members are anticipating these oscillations and engine noise changes, moments of surprise and instinctive engine failure immediate action items (lowering collective and controlling rotor speed) can be initiated. Crew coordination prior to system actuation can minimize the surprise associated with these events. For the conditions tested the anti-ice/bleed air system actuation characteristics are satisfactory.

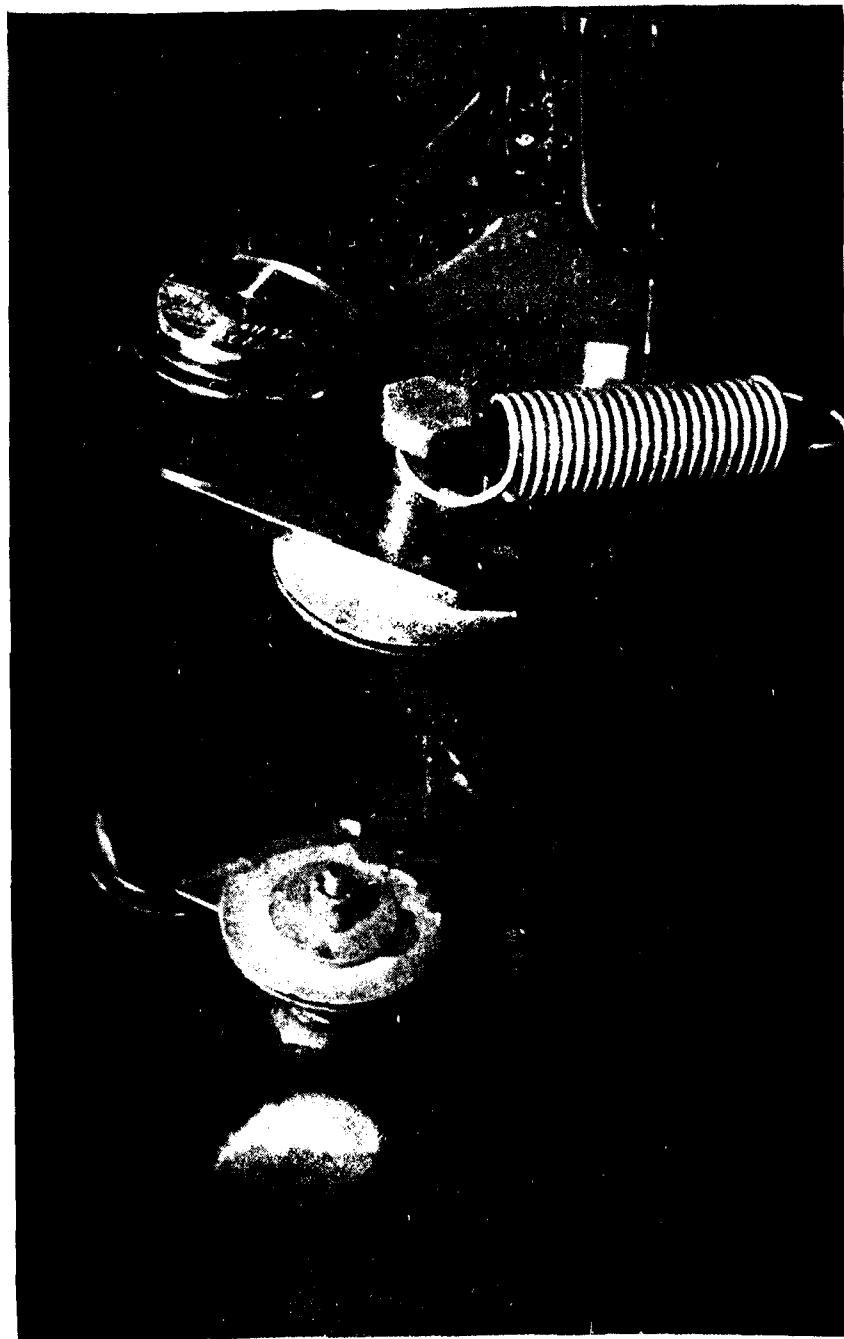
Photo 4. Unprotected Main Rotor Head
